**MULTICHIP MODULE
HIGH SPEED TESTING**ARPA/ONR
Grant N00014-91-J-4045Quarterly Progress Report
April 1, 1993-June 30, 1993**DTIC**
ELECTE
S A D
JUL 13 1993Robert J. Davis and David H. Auston, Principal Investigators
Department of Electrical Engineering
Columbia University
New York, NY 10027

Progress in the testing of multichip module electronic circuit packages for the period April 1, 1993 - June 30, 1993 is described below, in the areas of the testing of multichip modules using electrooptic polymers, the testing of high-speed transmission line structures, and the microfabrication of fiber optic test probes.

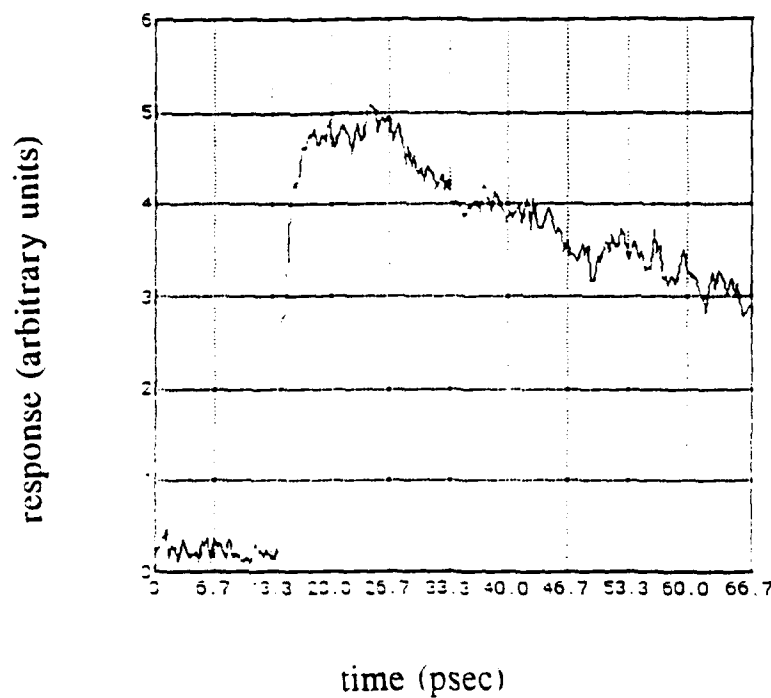
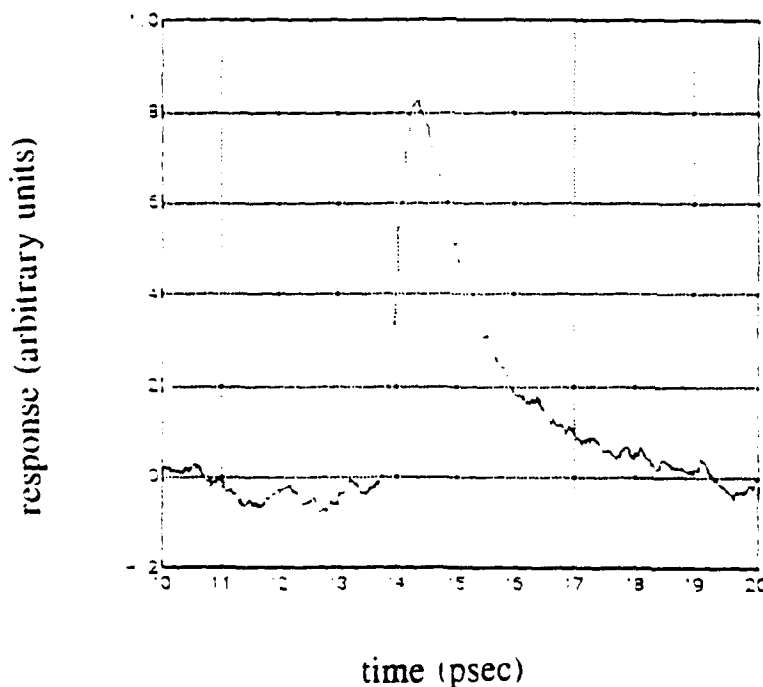
Fig. 1 Carrier lifetime in ion implanted, damaged GaAs, as measured by reflectivity measurements. In samples implanted at high dosage (top), the carrier lifetime is quite long, probably due to the annealing of the surface at high temperatures. Samples re-implanted with the same total dose (bottom), except at lower dosage, display the expected reduced lifetime. Thus, annealing of the GaAs surface during ion implantation must be considered in the fabrication of high speed radiation damaged GaAs electrooptic switches.

The two samples were ion implanted with high dosages after metals deposition to reduce the lifetime; however, as-implanted samples showed anomalously long carrier lifetimes (see Fig. 1) which may be due to the self-annealing of the GaAs surface during ion implantation at high dosage (and high temperature). However, re-implantation at lower dosage, which presumably results in a lower sample temperature, reduces the lifetime in the surface to approximately 2 psec (see again Fig. 1), demonstrating the need for control of the ion implantation dose in the fabrication of these GaAs electrooptic switches.
